# H Highlights

Of the Report to the Chairman,  
Board of Directors of the Elizabeth  
C-1 School District

## INFRASTRUCTURE ASSESSMENT

### Final Report by the Committee on the Physical Conditions and Adequacy of Facilities, Information/Technology and Transportation within the District

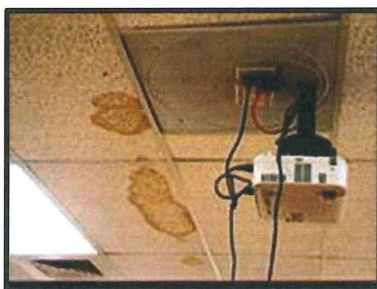
Figure 1: Water Damage - EHS

The committee has identified moisture infiltration as the greatest issue impacting the condition of the schools (fig 1). The specific conditions found include: failure of roofs, window seals, drainage, internal condensation, and failure of exterior water repellent coatings on masonry walls. Moisture penetration of building envelopes can lead to mold, damage to interior finishes and fixtures, and freeze/thaw cycles can ultimately be destructive to structural integrity. The committee recommends that the district address these issues soon in order to preserve and extend the useful life of the schools.

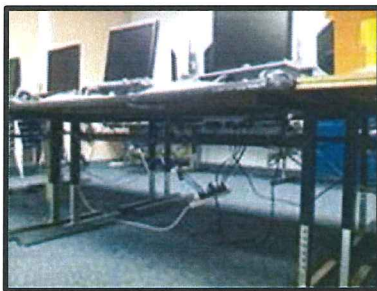
Figure 2: Power Cords - EMS

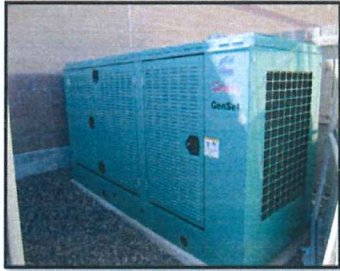
Figure 4: Back-up Generator- EHS

Utilities: EHS receives electricity via a single power line feed. Back-up power for life/safety systems is provided via an emergency generator with an automatic transfer switch. (fig 4) Domestic water is received from the city's public water utility and the fire hydrants and suppression systems are on a looped system. Public utility natural gas provides fuel for heating the building. The annual utility cost per student is \$260 based on current enrollment.

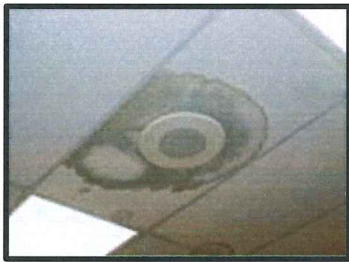
Figure 5: Water Damage - EHS

Overall Condition: The committee found EHS to be in generally very good condition. The building is well cared for by both custodial staff and the student body. There is clear evidence of pride in the school and little or no signs of abuse, graffiti, or neglect in regard to routine housekeeping. Moisture infiltration and condensation (fig 5) and deterioration of paved areas were the major issues found during on-site inspections. The top areas of concern raised by school staff were roof/door/window issues, air-conditioning, and building security. The committee believes that though there are issues which should be addressed in the near term, the overall condition of this building will not change appreciably in the next twelve to twenty-four months.

1) The district should inspect/repair and insulate all roof drains and bowls. Condensation on the bare metal on these drains generates significant moisture in the spaces above the drop ceilings. This has led to extensive staining of ceiling tiles and can promote mold growth and destroy interior finishes. This is a building longevity and health/safety issue.

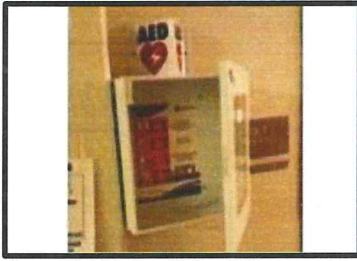
Figure 7: Missing AED - EHS

**Safety:** The school is relatively free of hazards though there is always room for improvement in this area. Hazards noted during the on-site inspections are as follows: In many classrooms, extensive use of extension cords and daisy-chained power strips were noted; both a trip and fire hazard. Throughout the school there are many broken or missing outlet and switch covers which expose users to electrical shock. Most classrooms have installed door stops that defeat the purpose of the automatic door closers and negate door fire ratings if these cause doors to remain open during a fire. Many toe-caps on main stairwell stairs are missing, loose, or held in place with duct tape; a trip hazard. Outdoors, there are extensive large cracks in the pavement of the main parking lots and at the joint between the sidewalk and the curb directly in front of the main entrance of the school; both trip hazards. Finally, though exterior lighting is generally adequate, the lights for one-third of the north-western main lot do not work increasing the trip/fall risk and risks of someone being struck by a vehicle. (Note: During the initial walk-through of this building, the AED (Automatic External Defibrillator) locker mounted outside the Health Office was found empty. (fig 7) The AED was present during a later inspection.)

4) The committee recommends a map with the location for all AEDs be posted by each device in the case that any one device is missing or out of service.

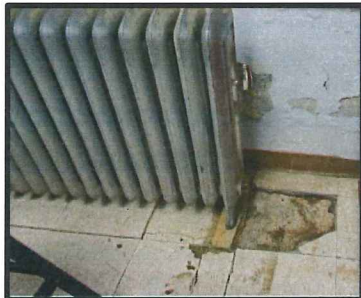
Figure 10: Deterioration - FHS

**Overall Condition:** Though the building is well cared for by both custodial staff and the student body, the committee found FHS to be in generally very poor condition due to its excessive age. (fig 10) Moisture infiltration due to failing doors and windows and general structure deterioration, inadequacy of HVAC, and lack of internal communication capability were the major issues found during on-site inspections. The top areas of concern raised by school staff were window issues, air-conditioning, adequacy of parking and building security. The committee believes that even if issues recommended for immediate correction are addressed in the near term, this building will continue to deteriorate and planning to replace this building should begin immediately.

2) The district should contract to repair the building envelope to reduce or eliminate moisture and air infiltration in order to slow the continuing deterioration of the building and lower heating costs which are approximately three times higher than the other schools in the district.

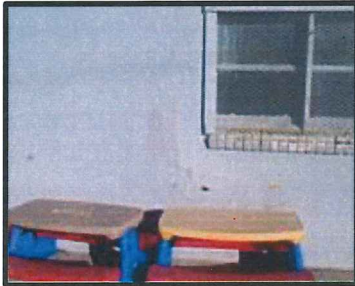
Figure 11: Deteriorated Stucco - FHS

Exterior and Grounds: As with the interior, extensive issues were found with the exterior of the building. Though the walls appear to be generally sound, the brickwork of the original building requires repointing, stucco (fig 11) on newer parts of the building is failing and painted surfaces are peeling. All this indicates that the building is subject to excessive moisture infiltration which will inevitably result in structural failure. Freeze/thaw cycles have caused considerable heaving and cracking of parking lot pavement in the lot adjacent to the building. The parking lot used by students to the east of the building suffers from badly deteriorated and poorly supported asphalt and is inadequately unlit. It is not suitable for use during inclement weather. Sidewalk slabs and exterior staircases also show considerable deterioration.

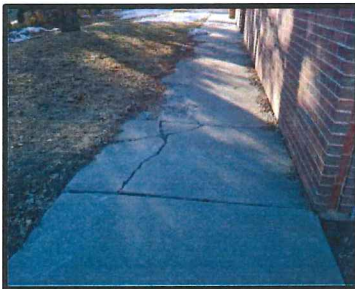
Figure 12: Uneven Sidewalk - FHS

Safety: The physical condition of this school presents multiple hazards to students and employees. Issues noted during the on-site inspections are as follows: In many classrooms, extensive use of extension cords and daisy-chained power strips were noted; both a trip and fire hazard. Throughout the school there are many broken or missing outlet and switch covers which expose users to electrical shock. Extensive use of electric space heaters increases the risk of fire in this older building. One room on second floor is being utilized as a wood shop. There is no ventilation, exhaust or dust collection system in the room. Shop vacuums and window fans are used to help limit dust migration. This is a health and fire hazard. Multiple power cords on portable tools have had the ground pin removed thus creating a shock hazard. Floor coverings are uneven and excessive flexibility of subfloors in several second floor rooms on the eastern side of the original building are troubling; both are trip hazards. The gymnasium bleachers are antiquated and present a hazard due to their proximity to the playing surface. The announcer's podium protrudes toward the court area at head height. The light fixtures in the gymnasium are not designed to resist impact and lenses/bulbs could fall if struck by a ball. Outdoors, there are extensive trip hazards. There are large cracks in the pavement of the main lot as well as uneven sidewalks leading to the main doors (fig 12). The uneven surface of the student parking lot also exposes users to trip hazards. Finally, exterior lighting is generally inadequate. The unlit parking lots are of particular concern due to increased trip/fall risk and risks of someone being struck by a vehicle.

- 1) The district should assess and repair the heating system within this building. This will reduce the need for electric space heaters reducing fire risk and provide a healthier work and learning environment.
- 2) The district should repair the prominent crack in the south wall of Room 115 in order to reduce water and air infiltration.
- 3) The main entrance doors and doors separating the school and the day-care and associated panic closure hardware should be replaced to reduce the threat of unauthorized access to this building.
- 4) The parking lot used by students should be graded and graveled to reduce trip/slip/fall hazards when funding is available.
